Re: Proposed Amendments for Licensing Standards for Day Care Homes (89 IAC 406), Day Care Centers (89 IAC 407), and Group Day Care Homes (89 IAC 408).

Putting children first: Tackling lead in water at child care facilities

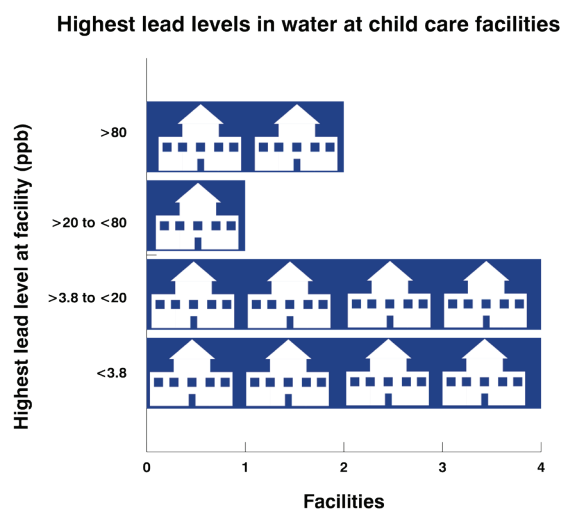
Graphic illustrates the highest lead level detected at each of 11 child care facilities, excluding samples from non-drinking sources such as utility sinks and hose bibs. Our pilot used a health-based action level of 3.8 ppb to trigger remediation.

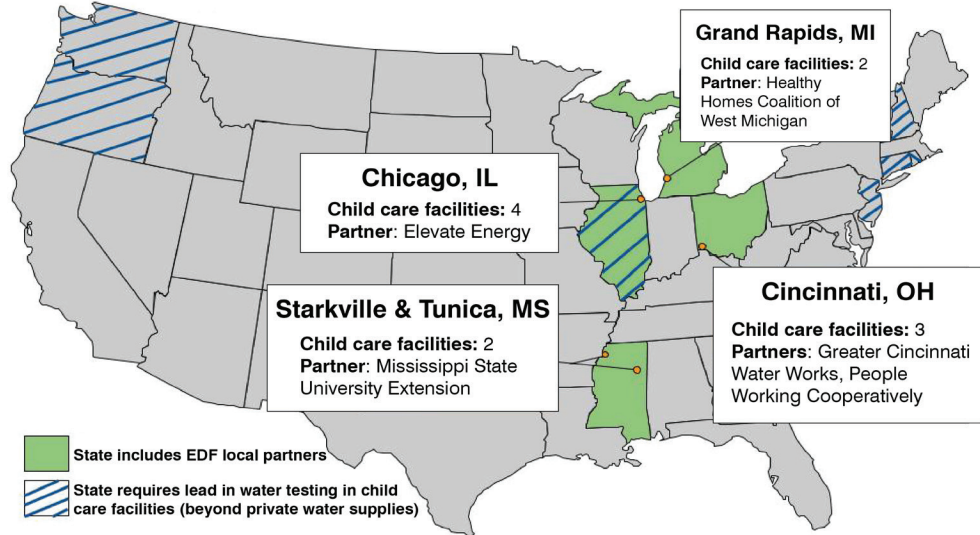
FIGURE 1
Lead in water at child care facilities: Existing requirements and EDF partners

EDF offered to pay for lead testing and remediation, which was conducted at 11 child care facilities serving over 1,000 children from primarily low-income families (see Figure 1 above). Our criterion for selecting child care facilities were that they serve as many children under six years of age from low-income families as possible in order to provide support to facilities that may not have the resources to tackle the issue on their own. Our local partners used their own networks and processes to recruit child care facilities into the pilot. They found it difficult to recruit both when they lacked a prior relationship with the child care facility and, for all but Chicago, when the facility did not anticipate a testing mandate in the future.

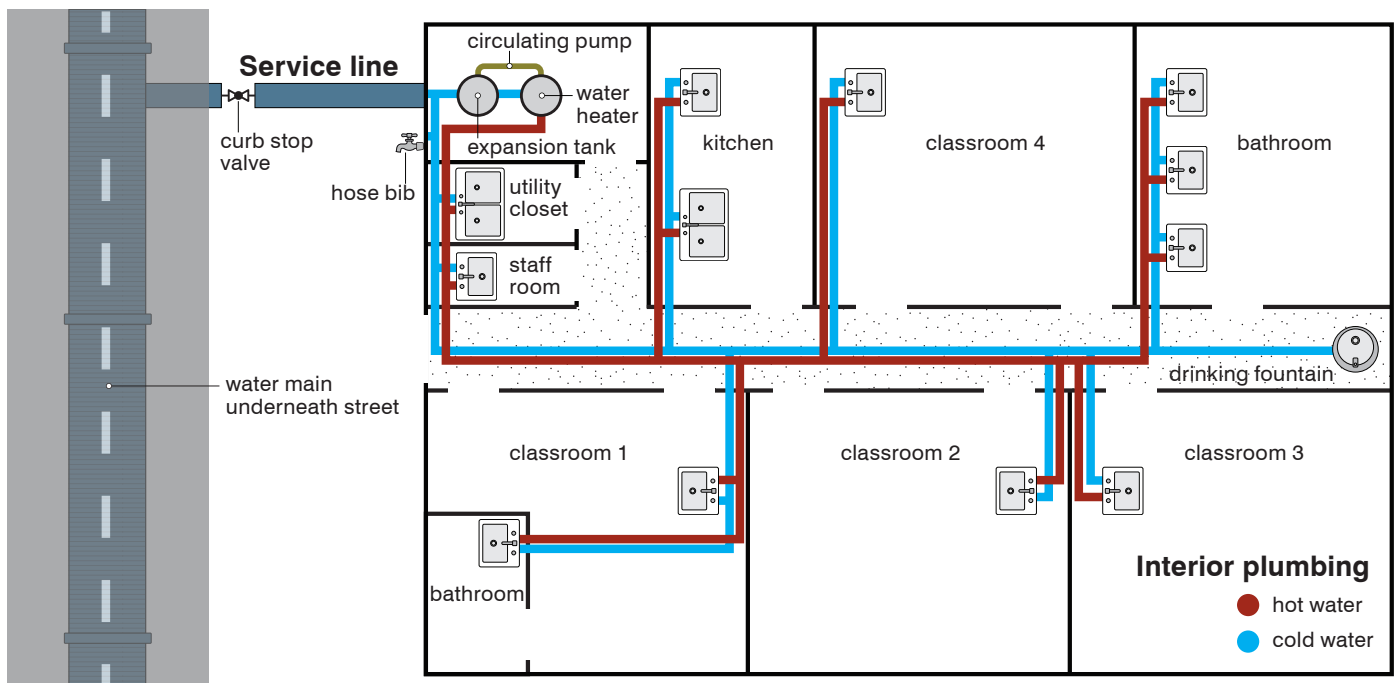
FIGURE 2

Water distribution system at typical center-based child care facility

The layout of the water distribution system in a typical center-based child care facility is illustrated in Figure 2. Water enters the building through the service line and is connected through interior plumbing. The service line usually enters the building near the water heater, which produces hot water for the facility (red). Large centers may have an expansion tank connected to the water heater, which manages pressure changes due to temperature fluctuations. Classrooms often have sinks and bathrooms, and most center-based facilities also have at least one kitchen, staff room, and utility closet.

Based on EPA's 3Ts guidance, our partners collected 250 mL water samples after allowing the water to sit in the pipes overnight (8-18 hour stagnation) at all water fixtures, including kitchen, classroom, bathroom, staff room, and utility closet sinks; drinking water fountains; and outdoor hose bibs (see Figure 2 above).

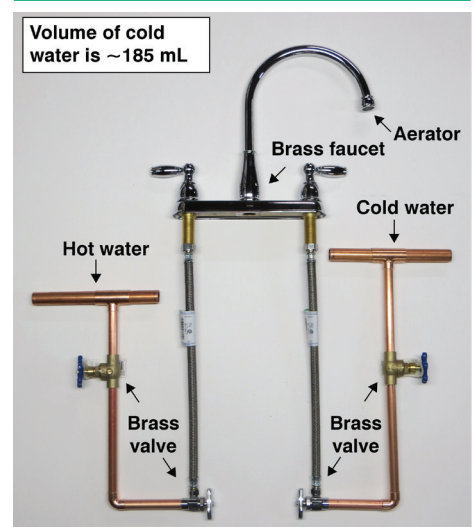
FIGURE 3

A typical brass faucet and associated plumbing is shown in Figure 3. In this example, the cold water volume—including the faucet through the plumbing shown—is about 185 mL. Therefore, a

Typical fixture and associated plumbing

250 mL sample (as recommended by EPA's 3Ts guidance) would include the faucet and associated plumbing beyond that pictured here.

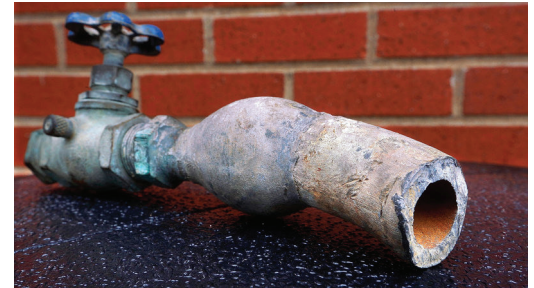
Image of a lead service line. Source: Associated Press.

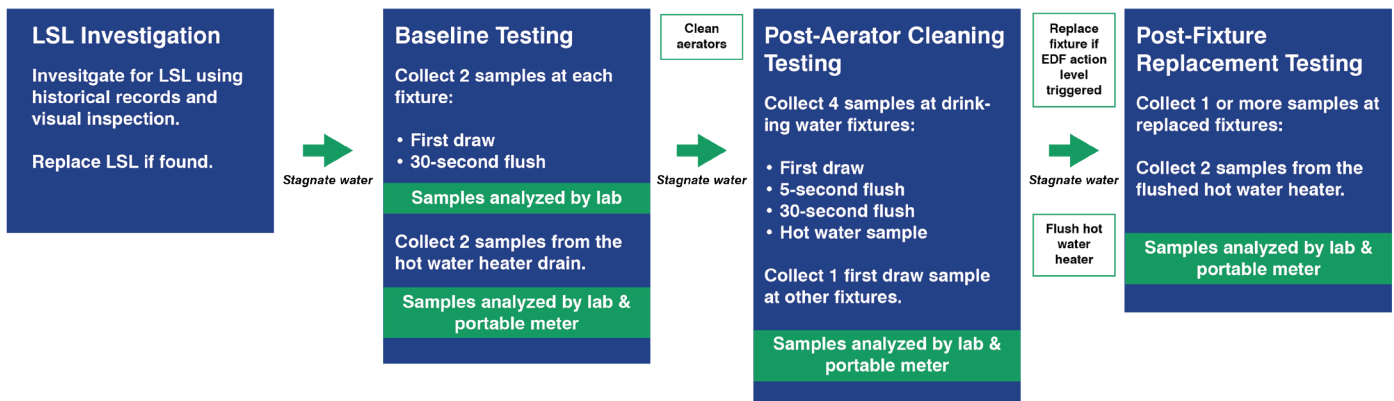
Our general sampling and remediation protocol is outlined in Figure 4. Our local partners conducted all lead sampling and coordinated remediation methods with the facilities. We adapted our protocol to local circumstances.

FIGURE 4
Lead in water testing protocol for EDF's pilot

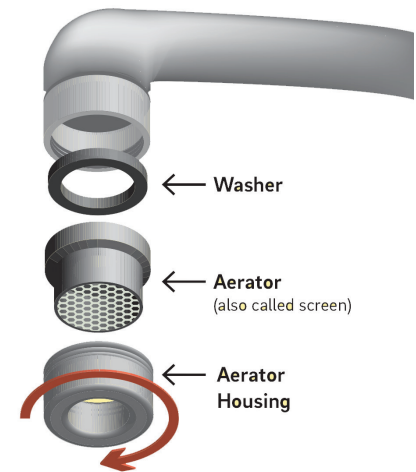
FIGURE 5
Diagram of faucet aerator

Where present, we cleaned the aerator—a screen often found at the end of a faucet—between the first and second day of sampling to remove lead particulates potentially caught in the screen. We removed the screens and washed them thoroughly in the tap water. See Figure 5.

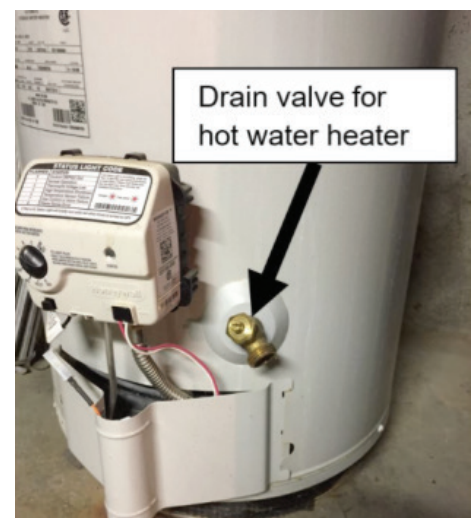
FIGURE 6
Water heater with drain valve

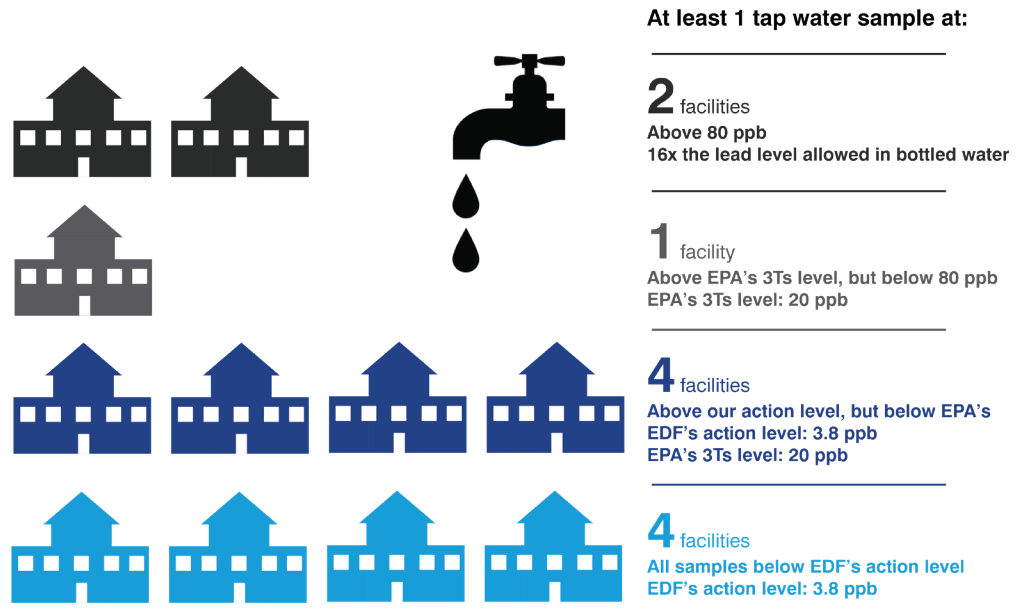
FIGURE 7

Highest lead levels in drinking water at 11 child care facilities

Results of water testing (excluding samples from utility sinks and hose bibs) at 11 child care facilities: two facilities had at least one tap water sample above 80 ppb level of lead; one facility had at least one sample above EPA's 3Ts action level of 20 ppb, but below 80 ppb; four facilities had at least one sample above our health-based action level of 3.8 ppb, but below 20 ppb; and 4 facilities had all samples below EDF's action level of 3.8 ppb.

We found that four of the 11 child care facilities had no drinking water fixtures exceeding our action level of 3.8 ppb while seven had at least one drinking water fixture that triggered our action level on either day one or two of sampling—and therefore could be source of lead exposure to children in the facility. Of these, three were above the EPA 3Ts action level of 20 ppb with two facilities, in Chicago and Cincinnati, with highs greater than 80 ppb. The highest drinking water samples at the remaining four facilities were between our action level and EPA's current 3Ts action level. See Figure 7.

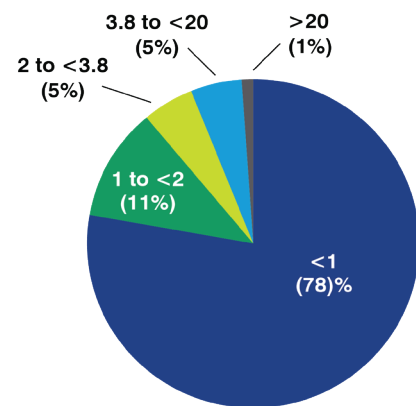
FIGURE 8

Lead levels in baseline first draw samples (ppb)

Figure 8 provides the results for the first draw baseline samples—samples modeled after EPA's 3Ts guidance—for the 291 fixtures we tested.³ More than three out of four of the baseline first draw samples had levels below 1 ppb. Seventeen of 291 (6%) exceeded our action level of 3.8 ppb and only two (1%) exceeded EPA's 3Ts trigger of 20 ppb. On average, lead levels were higher on the second day of testing, following aerator cleaning (see page 21).

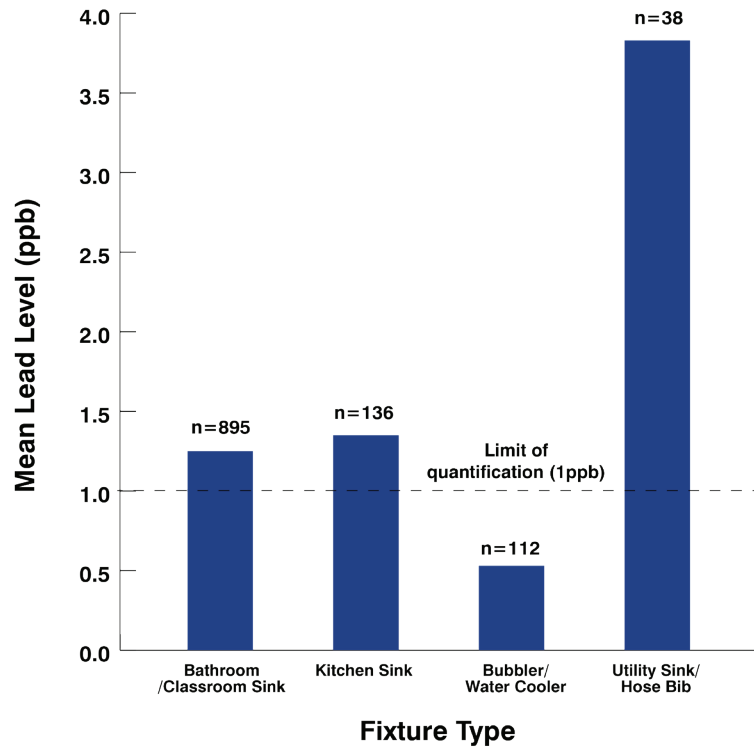
FIGURE 9
Mean lead level by fixture type

This chart illustrates the mean lead levels by fixture type for all samples (excluding those collected before LSL replacement or after fixture replacement as well as hot water samples). When levels were below the limit of quantification (1 ppb), we used 0.5 ppb.

Samples also varied by fixture type. Figure 9 illustrates the mean lead level by fixture type. Drinking water fountains (bubblers and water coolers) had the lowest lead levels, with nearly all non-detectible lead levels (non-detects reported as 0.5 ppb in Figure 9). Kitchen sinks had an average lead level of 1.4 ppb (range <1-27 ppb). Though we had a limited sample size, non-drinking water faucets, like utility sinks and outside hose bibs, had the highest lead levels (average 3.8 ppb, range <1-35.6 ppb).

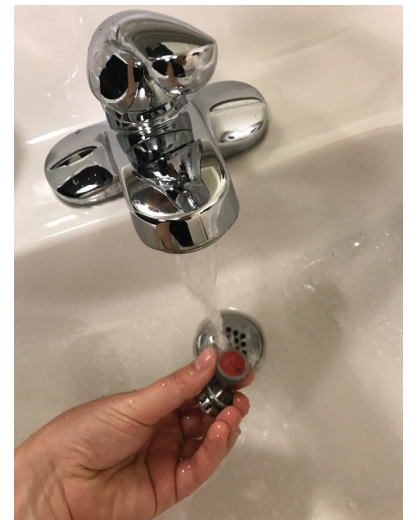
Partner with Healthy Homes Coalition of West Michigan cleans a faucet aerator.

We think that aerator cleaning may increase lead levels by disturbing particulates stuck in the aerator screen without fully flushing them out. If true, one option to minimize such an effect is to soak aerators in vinegar for a few minutes, allowing the lead particulate to dissolve and easily be washed away. Some existing aerator

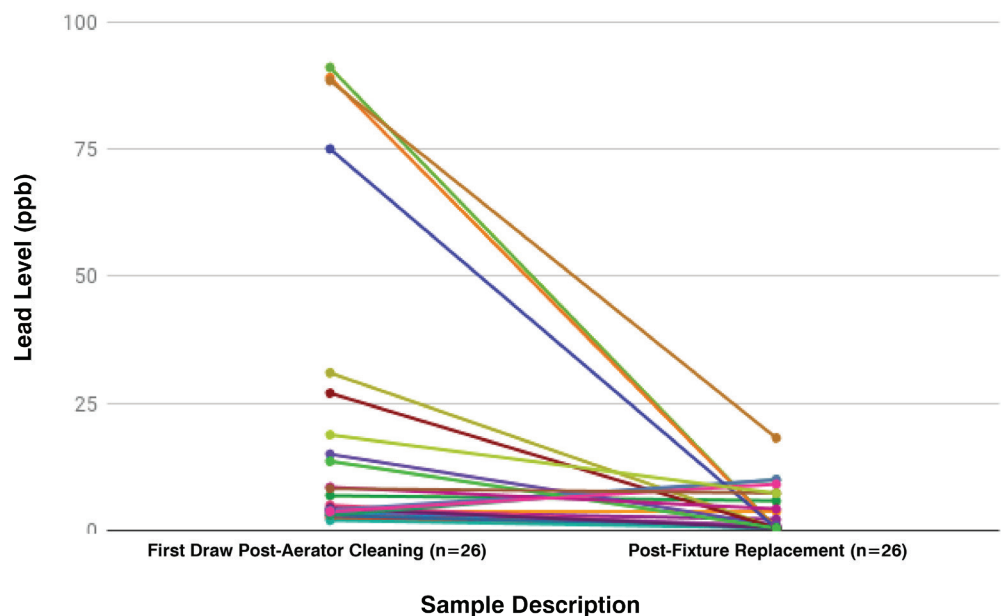
FIGURE 10

Lead levels before and after fixture replacement (all samples)

This chart illustrates lead levels at fixtures for first draw post-aerator cleaning and post-fixture replacement. Lines connect data for a single fixture.

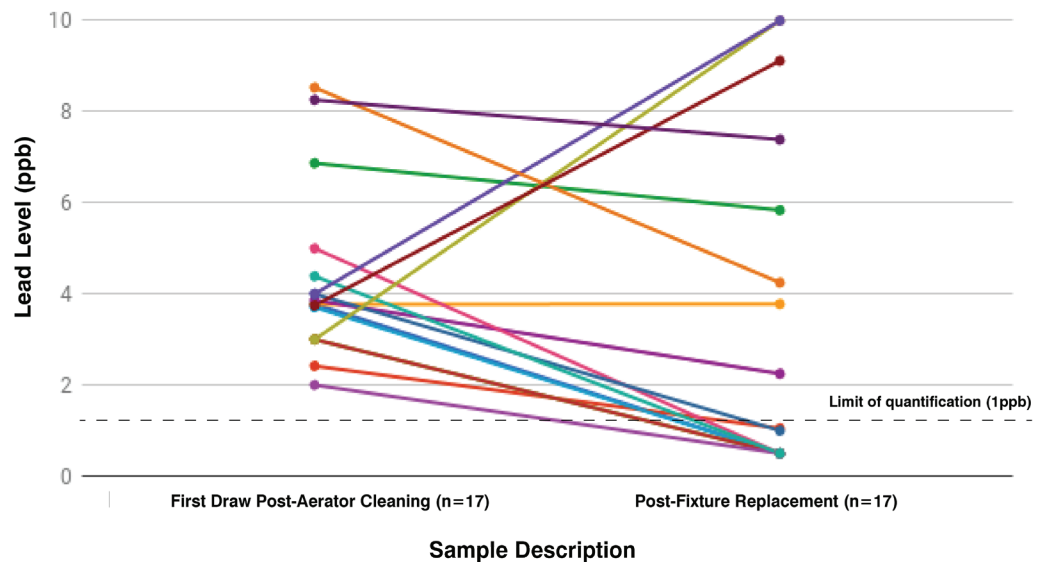
FIGURE 11
Lead level before and after fixture replacement when baseline samples ≤ 10 ppb

This chart illustrates lead levels at fixtures for first draw post-aerator cleaning and post-fixture replacement when the initial sample was 10 ppb or lower. Lines connect data for a single fixture. The limit of quantification for ICP-MS (1 ppb) is indicated with a dashed line; samples below the limit of quantification are plotted at 0.5 ppb.

However, where lead levels were initially close to our action level, replacement was not consistently effective (see Figure 11). In fact, when levels post-aerator cleaning were <5 ppb, fixture replacement on average resulted in a 2.0 ppb (± 1.0 ppb) increase in lead levels. While most initial follow-up testing results were under our action level (71%), a handful of fixtures (29%) tested above our action level following replacement. At two facilities, we conducted follow-up testing within 1-2 days after replacement. Three of these fixtures temporarily had higher lead levels following fixture replacement than prior to replacement, but decreased over time (data on decrease over time not shown).

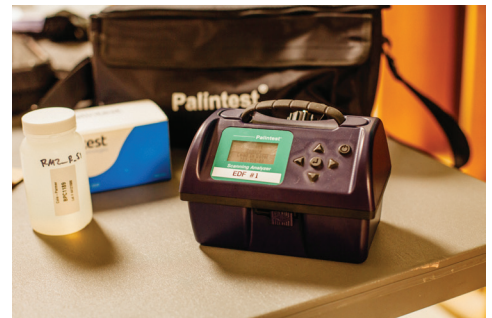
Palintest meter. Photo credit: Danielle Scruggs.

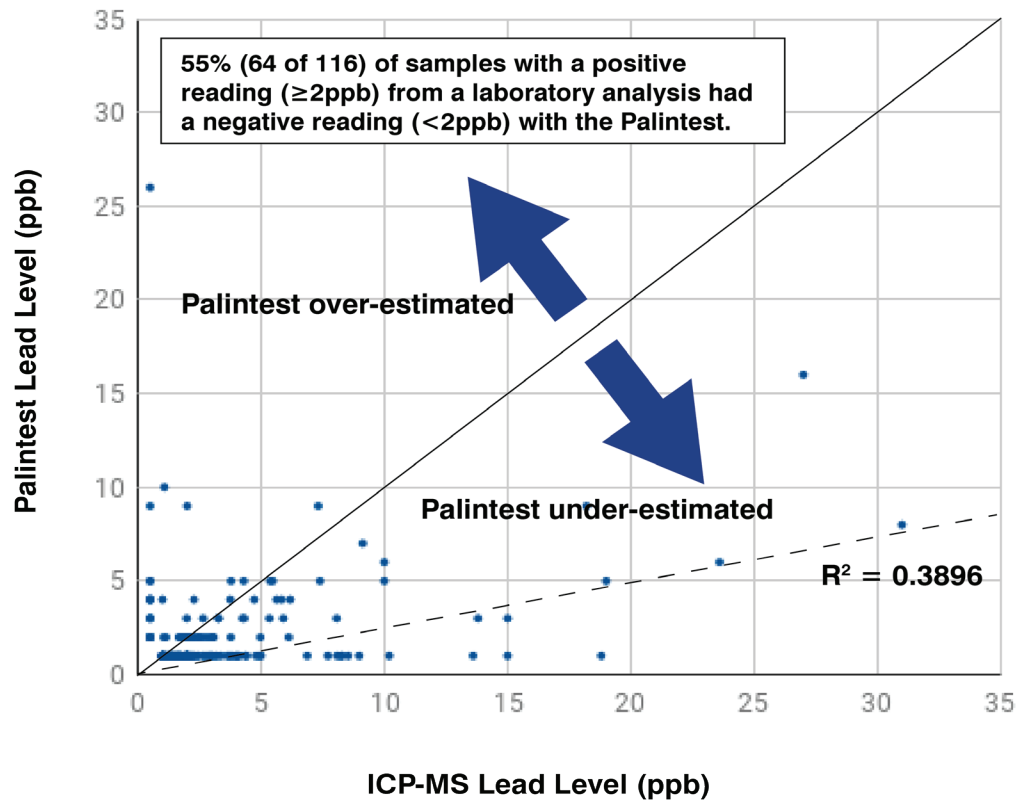
FIGURE 12
Comparing Palintest and ICP-MS lab results

This chart compares sample results from the Palintest meter to the ICP-MS laboratory analysis. When the reading was below the limit of quantification (2 ppb for Palintest and 1 ppb for ICP-MS), we plotted the value at half the limit of quantification. The dotted line represents the observed correlation between the ICP-MS and Palintest measurements, while the solid line represents what the trendline would be if the two tests were perfectly correlated.

Palintest portable lead meter tended to underestimate lead in water levels compared to the laboratory analysis (Figure 12), likely because the Palintest protocol does not include a full acid digestion to solubilize any particulate lead. Of 116 samples, 55% (64) with a positive reading (≥ 2 ppb) from laboratory analysis had a negative reading (< 2 ppb) with the Palintest. In 18 instances (11% of the samples), the Palintest had a positive reading (≥ 2 ppb) while the laboratory results were below the limit of quantification (< 1 ppb); however, 14 of these samples came from the same meter and we suspect there may have been a technical issue resulting in false readings.

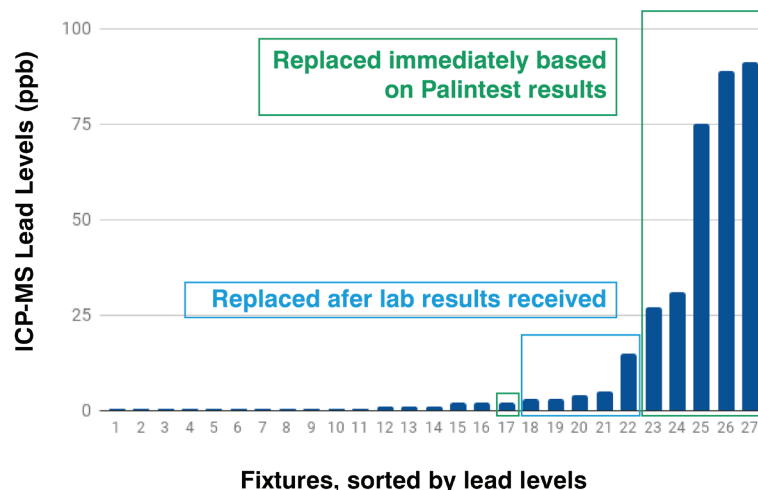
FIGURE 13

ICP-MS results for 27 drinking water fixtures

We received the laboratory results 18 days after fixture replacement. The lab results demonstrated that 10 drinking water fixtures had lead levels above the action level we used in Chicago (>2 ppb). The five with the highest ICP-MS levels (27-91 ppb) had been flagged by the Palintest meter and had already been replaced (Figure 13). The sixth fixture we had replaced based on the Palintest meter (#17 on Figure 13), had a lead level of just 2 ppb based on the ICP-MS analysis. We would not have replaced this fixture based on the ICP-MS results.

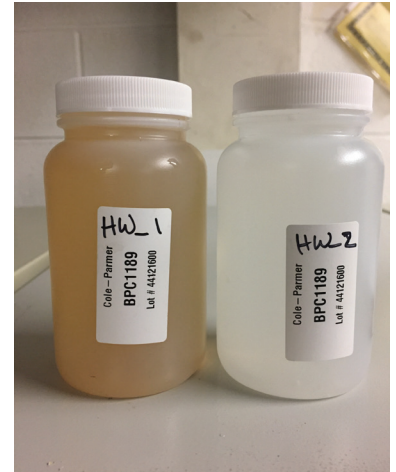
Water samples collected directly from water heater drain. Initial draw pictured on the left.

We found alarmingly high lead levels from the samples collected from the drains of hot water heaters, which we think likely accumulated over time from upstream sources of lead. Half (seven of 14) of water heater tanks tested in child care facilities had levels over 50 ppb, with one as high as 2,680 ppb. The initial samples from the water heater often were discolored—some even like a sludge.

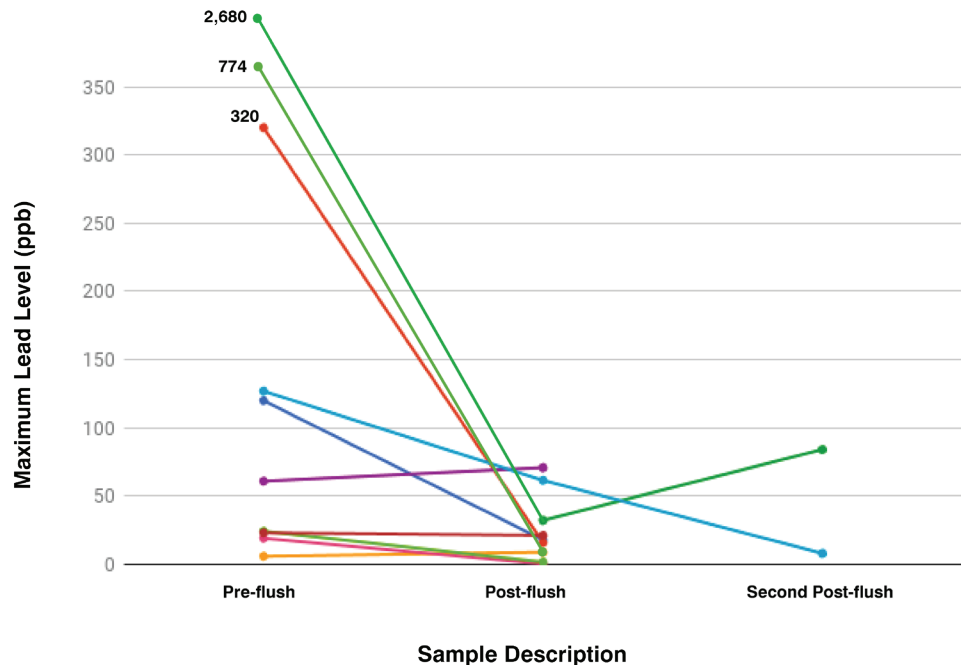
FIGURE 14
Lead results for 10 water heaters: Before and after flushing

Measured lead levels in 250 mL of water collected from 10 hot water heaters in 9 child care facilities. Pictured: Highest lead level detected during each sampling phase—the initial sampling (pre-flush), following a full flush of the water heater (post-flush), and following a second flush of the water heater (second post-flush). Lines connect data for a single water heater.

Our partners performed sustained flushes through the drain on 10 water heater tanks to remove accumulated sludge and particulate (Figure 14). The flushing helped significantly in all but one case. Among water heaters where initial samples tested above 50 ppb, flushing dropped the lead levels on average from 456 ppb to 20 ppb. When initial water heater samples tested below 50 ppb, the drop was less evident (from 17 ppb pre-flush to 13 ppb post-flush, on average). In two cases, our partners performed second flushes in an attempt to further reduce the lead levels (with mixed results). Flushing the water heater can be challenging, however, if there is not a floor drain nearby. Some facilities may need a plumber’s assistance to perform a sustained flush of the water heater.
